# The Colregs and the *Princess Alice*

J.F. Kemp

*Marine Navigation Consultant, Arundel, UK*

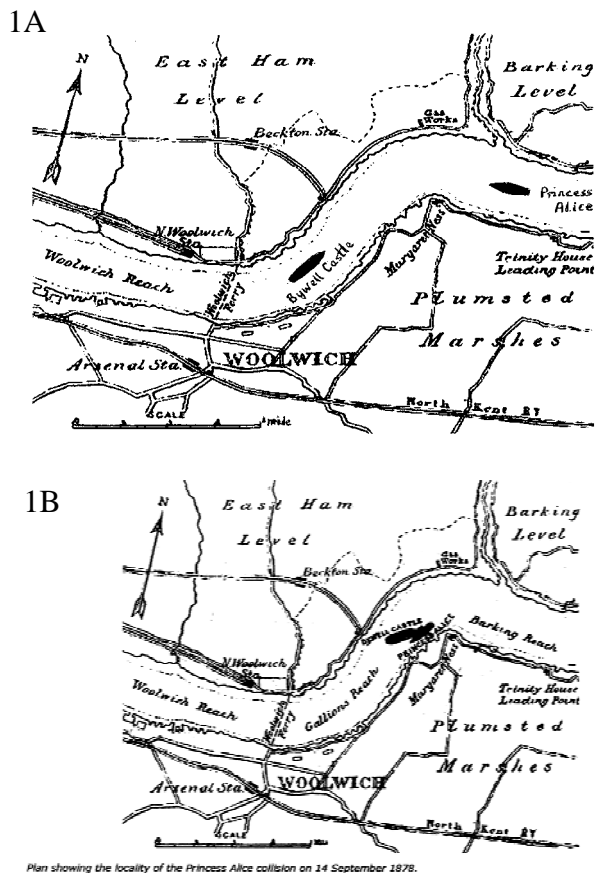
At about 1945, Captain Harrison and his pilot, Captain Dix, were on the upper bridge. Their ship was proceeding at half speed down the centre of Gallions Reach. An ebb tide was running, which would have increased the *Bywell Castle's* speed from 5 knots through the water to about 6 knots over the ground. (See figs 1A and 1B.)

Fig. 1. The positions of the *Princess Alice* and the *Bywell Castle* at 5 minutes before the collision (1A), and at the time of the collision (1B), based on a contemporary chart

Captain Harrison did not have a difficult decision. On seeing the lights of the *Princess Alice*, he altered course to starboard, which took him nearer to the south shore. This measure was in accordance with the suspended rule that ships should keep to the starboard side of narrow channels. It also avoided crossing the bows of the *Princess Alice*. The *Bywell Castle* would, in any case, have soon needed to turn to starboard to negotiate the bend in the river. Finally, since his ship was in ballast, Captain Harrison would not have been unduly worried by the relatively shallow water that tends to accrue on the inside of bends.

At 1945, the *Princess Alice* was in Barking Reach, approaching Tripcock Point (Margaret Ness). She was making 11 knots through the water, which the ebb-tide would have reduced to about 10 knots over the ground. (See figs 1A and 1B.)

In the event, Captain Grinsted chose to alter course to port. A bad move as it turned out, but he had probably made many similar decisions in the past, with perfectly satisfactory results. Whatever the case, the author would not have liked to have been in Captain Grinsted's shoes, and to have faced the dilemma he had to resolve only four minutes before the collision.
