Total losses of fishing vessels due to the insufficient stability

P. Krata

Gdynia Maritime University, Gdynia, Poland

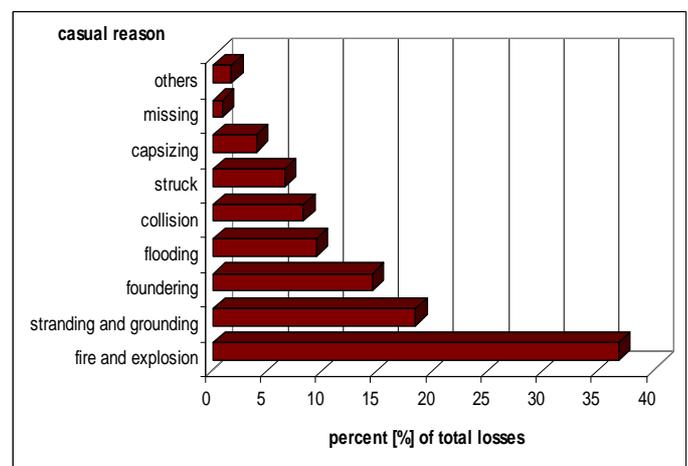
Fig. 1. Distribution of the reason of fishing vessel total losses (source - own study based on data published in (Achutegui, Mendiola & Azofra 2000))

The distribution of the reason of analyzed fishing vessels' total losses is shown graphical in figure 1. The loss of stability involving capsizing of the ship is one of the rarely noticed reason of the total losses.

Its rate is only 4% of all casual causes. Although the rate of capsized vessels is much higher in the group of smaller ships, not considered in presented statistics.

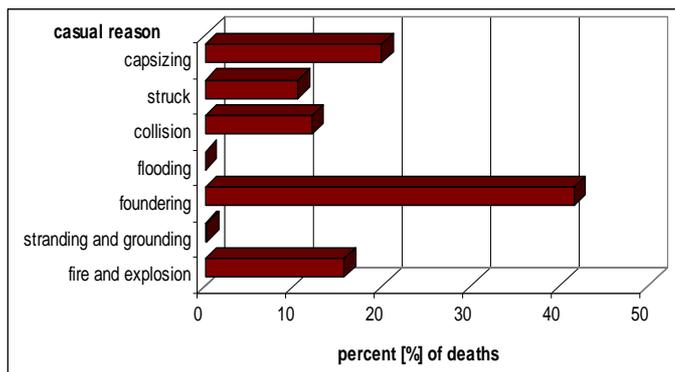
Fig. 2. Distribution of the causes for deaths during fishing vessel total losses (source - own study based on data published in (Achutegui, Mendiola & Azofra 2000))

important reason of deaths on board of fishing vessels. The distribution of causes for loss of human life during fishing vessels' total losses is shown in figure 2.

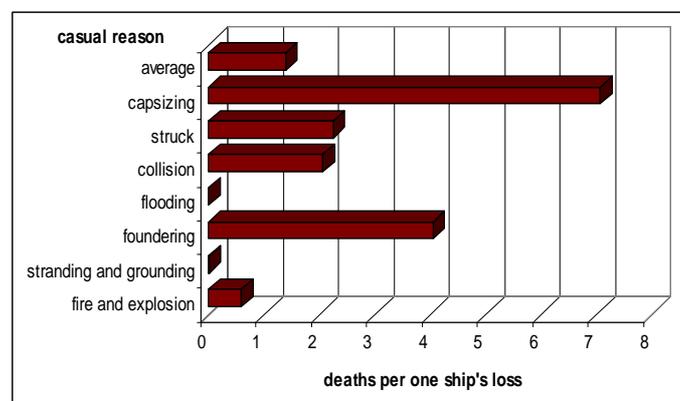
Fig. 3. Distribution of the causes for deaths per one fishing vessel total loss (source - own study based on data published in (Achutegui, Mendiola & Azofra 2000))

Capsizing is the second often reason of the loss of human life, although it causes only 4% of all total losses of fishing vessels. The rate of deaths during capsizing reaches almost 20%. The rate of death per one ship's loss is even worse. It is 7,07 loss of human being per one fishing vessel lost, when the average rate is 1,40 only. The distribution of the causes for deaths per one fishing vessel total loss is shown in figure 3.

The comparison of the average rate of deaths and the characteristic high rate noticed for capsizing, shows the level of threat during the capsizing and generally the condition of insufficient stability. The rate of deaths per one capsizing disaster, which is over five time higher than average one, justify further consideration of this relative rare phenomenon.

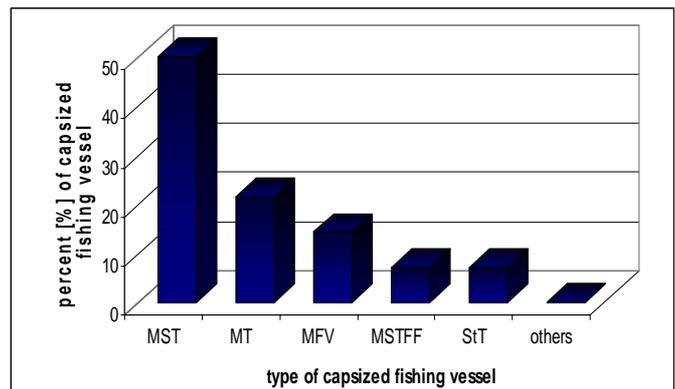
Fig. 4. Distribution of capsizing rate by the type of lost vessel (source - own study based on data published in (Achutegui, Mendiola & Azofra 2000))

The distribution of capsizing rate by the type of the vessels is shown in figure 4. The symbols used in the graph are following: MST - motor stern trawlers, MT - motor trawlers, MFV - motor fishing vessels, MSTFF - motor stern trawlers fish factory, StT - steam trawlers. The names of vessels types correspond with the division used for statistic data collecting (Achutegui, Mendiola & Azofra 2000).

The predominating group of capsized fishing vessels represents motor stern trawlers and the second one motor trawlers. Those both types of ships suffered over 71% of all capsizing. It is characteristic for both of them, that the freeboard is relatively small. Additionally the stern trawlers have low and almost open stern, what is necessary for the type of fishing operations. The coexistence of such shape of the trawlers hull and the high rate of capsizing should be underlined.

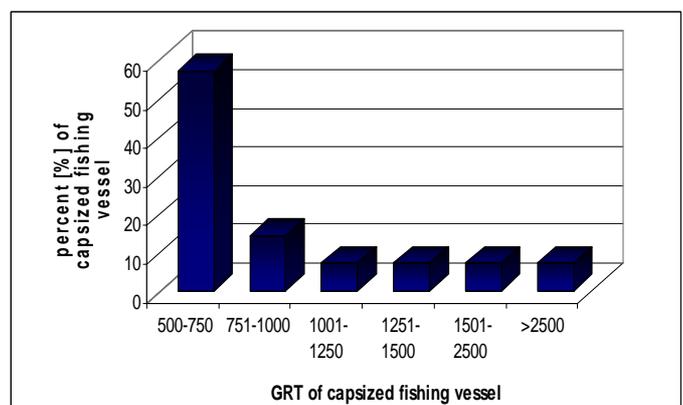
Fig. 5. Distribution of capsizing rate by GRT of lost vessel (source - own study based on data published in (Achutegui, Mendiola & Azofra 2000))

The next step was taking into consideration the size of the capsized fishing vessels. Six sizes up to the gross register tonnage were established. The distribution of capsizing rate by the GRT of fishing vessels is shown in figure 5. There is the strong relationship between the size of considered vessels and the rate of its capsizing. Over 57 % of capsized ships were under 750 GRT. The vessels of size smaller than 500 GRT were not taken into consideration.

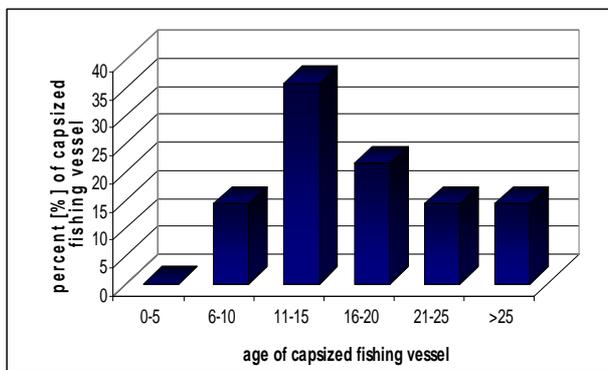
Fig. 6. Distribution of capsizing rate by the age of lost vessel (source - own study based on data published in (Achutegui, Mendiola & Azofra 2000))

The last factor taken into consideration was the age of the capsized fishing vessels. Six age categories were established: ships from 0 to 5 years old - "new", 6 to 10 years old - "relatively new", from 11 to 15 years old - "middle age", 16 to 20 years old - "relatively old", 21 - 25 years old were considered as "old" and over 25 years old - "very old". The distribution of capsizing rate by the age of fishing vessel is shown in figure 6.

The highest rate of capsizing was noticed for middle age ships (almost 36% of all capsized fishing vessels). The second most inflicted to capsizing group of vessels are relatively old ones. The figure 6. shows, that there is no rule - the older the worse.

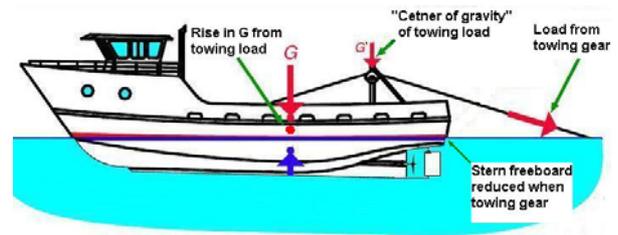
Fig. 7. The towing load affecting ship's stability (source (Womack 2002))

The criteria adopted by IMO represent the simple static attitude towards complicated nonlinear dynamic behavior of the vessel. The weather criterion, which is the attempt of dynamic stability calculation, is based on the static righting arm as well. The vessels shall be able to withstand the effect of severe wind and rolling in associated sea conditions in which the vessel will operate (IMO 1993). But no dynamic evaluation of the rolling and wind gusts take place in course of stability calculation. Additionally, when the stability of fishing vessel is to be evaluated, some important circumstances are omitted. First of all the influence of fishing gear's towing should be taken into consideration. The arrangement of additional forces affecting the trawler is shown in figure 7.

Another effect resulting the danger to fishing vessels may be the water trapped on deck and its dynamic influence (Jankowski & Laskowski 2006). Such situation is most likely during the towing of fishing gear by the small trawler. There is an accumulation of free board lowering (see figure 7) and the characteristic construction of stern trawlers having almost open stern for fishing operations. The water trapped on the deck may also come into the processing spaces, what considerably effects the ships stability and results deeper rolling on the seas. The example of such situation may be the capsizing of fishing vessel *Arctic Rose*. The disaster was described in details (Lieutenant 2002).

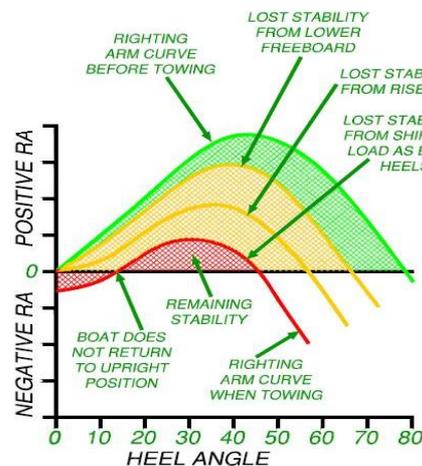
Fig. 8. Negative effects of towing of fishing gear (source (Womack 2002))

The stability of the vessel towing the fishing gear is reduced by some effects. The first is the rise of the center of gravity, due to fishing gear load placed virtually on the top of cable reels. The other reason for the stability decay is the lower freeboard, especially in the stern of the trawler. That may be the reason of the loss of relatively small ships, which capsize the most often (see statistic in figure 5). The next factor affecting ships' stability is the shift of load as the vessel heel. The negative effects of towing the fishing gear are shown in figure 8.

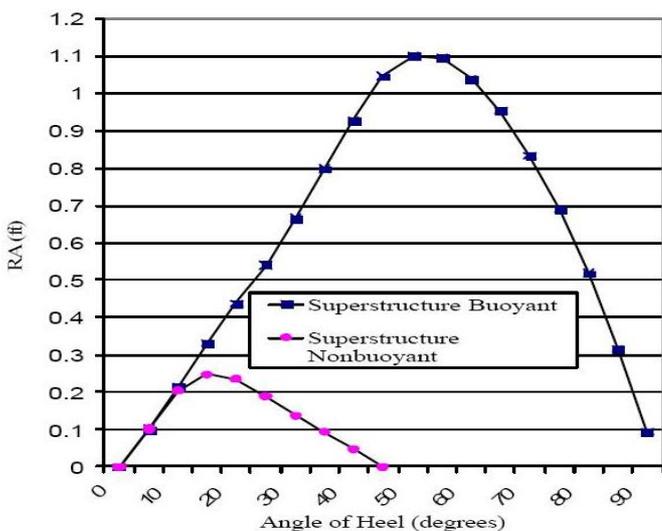
Fig. 9. Arctic Rose righting arm curve RA: openings closed - upper curve and openings remaining open - lower curve (source (Lieutenant 2002))

The fishing vessel *Arctic Rose* had been disappeared in the Bering Sea on April 2, 2001, killing all fifteen men onboard. The U. S. Coast Guard convened a Formal Marine Board of Investigation to determine what had happened to the vessel and why it had happened. According to the analysis, the most likely reason the *Arctic Rose* sank had been progressive flooding from the aft weather deck to the processing space and the flooding then progressed to the galley, fish hold, and engine room through non-watertight doors and hatches (Lieutenant 2002). The effect of loss of buoyancy of the superstructure on the static righting arm curve is shown in figure 9. With the superstructure nonbuoyant, the angle of maximum righting arm is at the angle of deck edge immersion. With the superstructure buoyant, the angle of maximum righting arm is increased to the angle at which the top of the superstructure is immersed. However, if the superstructure cannot physically be kept watertight due to openings without closures and operational considerations, the buoyancy is lost (Lieutenant 2002).

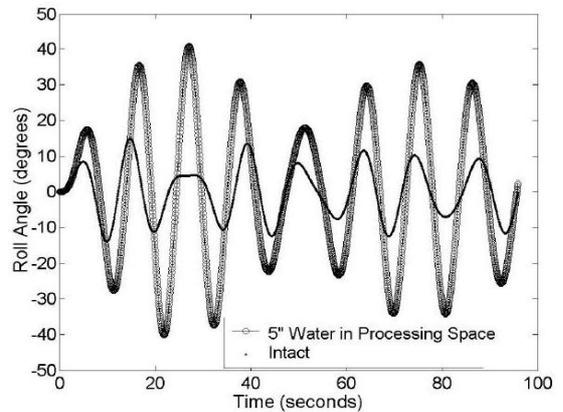
Fig. 10. Roll angle time history for Arctic Rose (source (Lieutenant 2002))

Additionally, water on deck often leads to progressive flooding into spaces inside the fishing vessel in which watertight doors and hatches have been left open, which is precisely the most likely scenario of the loss of the *Arctic Rose* (Lieutenant 2002). The sophisticated analysis of dynamic behavior of *Arctic Rose* containing the water inside its hull was performed. The results of the analysis are shown in figure 10. The great increase in rolling amplitude is evident.
